BULLETIN SUBJECT:

Oxford Advance - Leg Locking Mechanism

Product Group:	Oxford Professional Series	Model(s) Affected:	Oxford Advance
Effectivity Date:	Immediate	Serial No. Affective From:	N/A

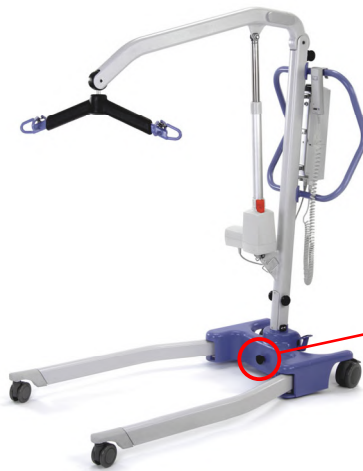
The black leg locking knob on the Oxford Advance hoist is designed to ensure the legs are either locked out in position prior to use or disengaged in preparation for folding. Failure to ensure this knob is securely engaged and the legs locked into a parallel position before use could lead to subsequent collapse of the hoist and injury to patient and or caregiver.

Fig. 1
Showing location of leg locking knob and legs locked out in parallel prior to use.

- Always read and understand the guidance contained in the user instruction manual including conducting daily checks prior to using your Oxford Advance hoist.
- Observe all warning decals on the product to help ensure the safety of both patient and caregiver.
- Prior to carrying out any lifting/transfer with the Advance hoist, verify and ensure the legs are securely locked into parallel position (Fig. 1) and cannot be adjusted inwards or outwards without operating the leg pedal.

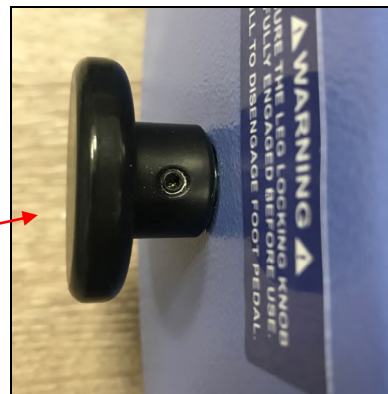
Fig. 2
Close up of leg locking knob and accompanying warning decal.
